Manhole Inspection Summary

Manhole # S05EE2010MH

Insp Date: **7/17/06 10:34 AM**

Location Address: **2615 TANEY RD**

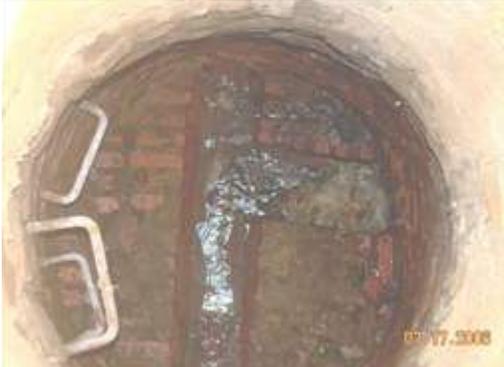
Top View

Frame leaks. Adjustment, Corbel and Barrel infiltration. Evidence of surcharge - Bench debris. Channel debris.

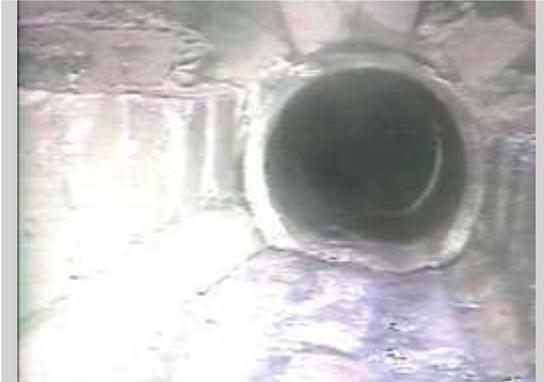
8 in. Circular Gravity Sewer
Pipe Out @ 12 O'Clock

Infiltration: **Evidence** Pipe Seal Cond: **Broken**

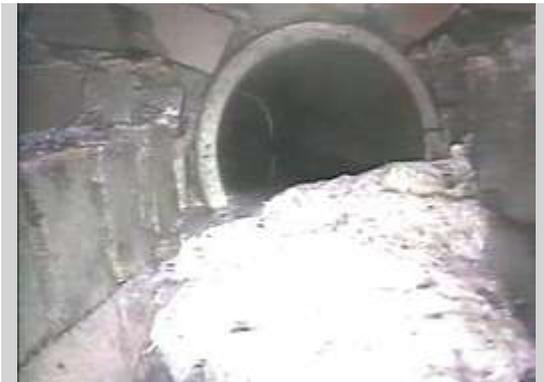
8 in. Circular Gravity Sewer
Pipe In @ 3 O'Clock

Deposits: None Mud Sludge **Debris** Grease

Silt Depth: **1** (in.) Deposits Extent: **Light**

Infiltration: **Evidence** Pipe Seal Cond: **Cracked**

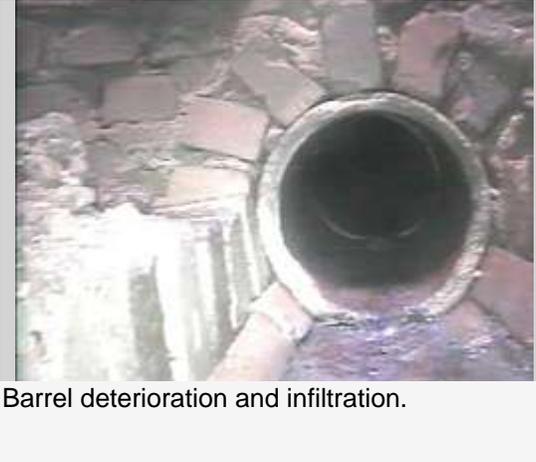
Pipe In @ 6 O'Clock

Comments **The I6 pipe picture shows Barrel deterioration and infiltration. The I6 pipe seal is not flush to the pipe.**

Barrel deterioration and infiltration.

Infiltration: **Evidence** Pipe Seal Cond: **Unknown**
